2008 ANNUAL REPORT

CANYON FUEL COMPANY, LLC SUFCO MINE ACT/041/002

Re: 2008 Annual Report for Canyon Fuel Company LLC, SUFCO Mine
C/041/002, Sevier County, Utah

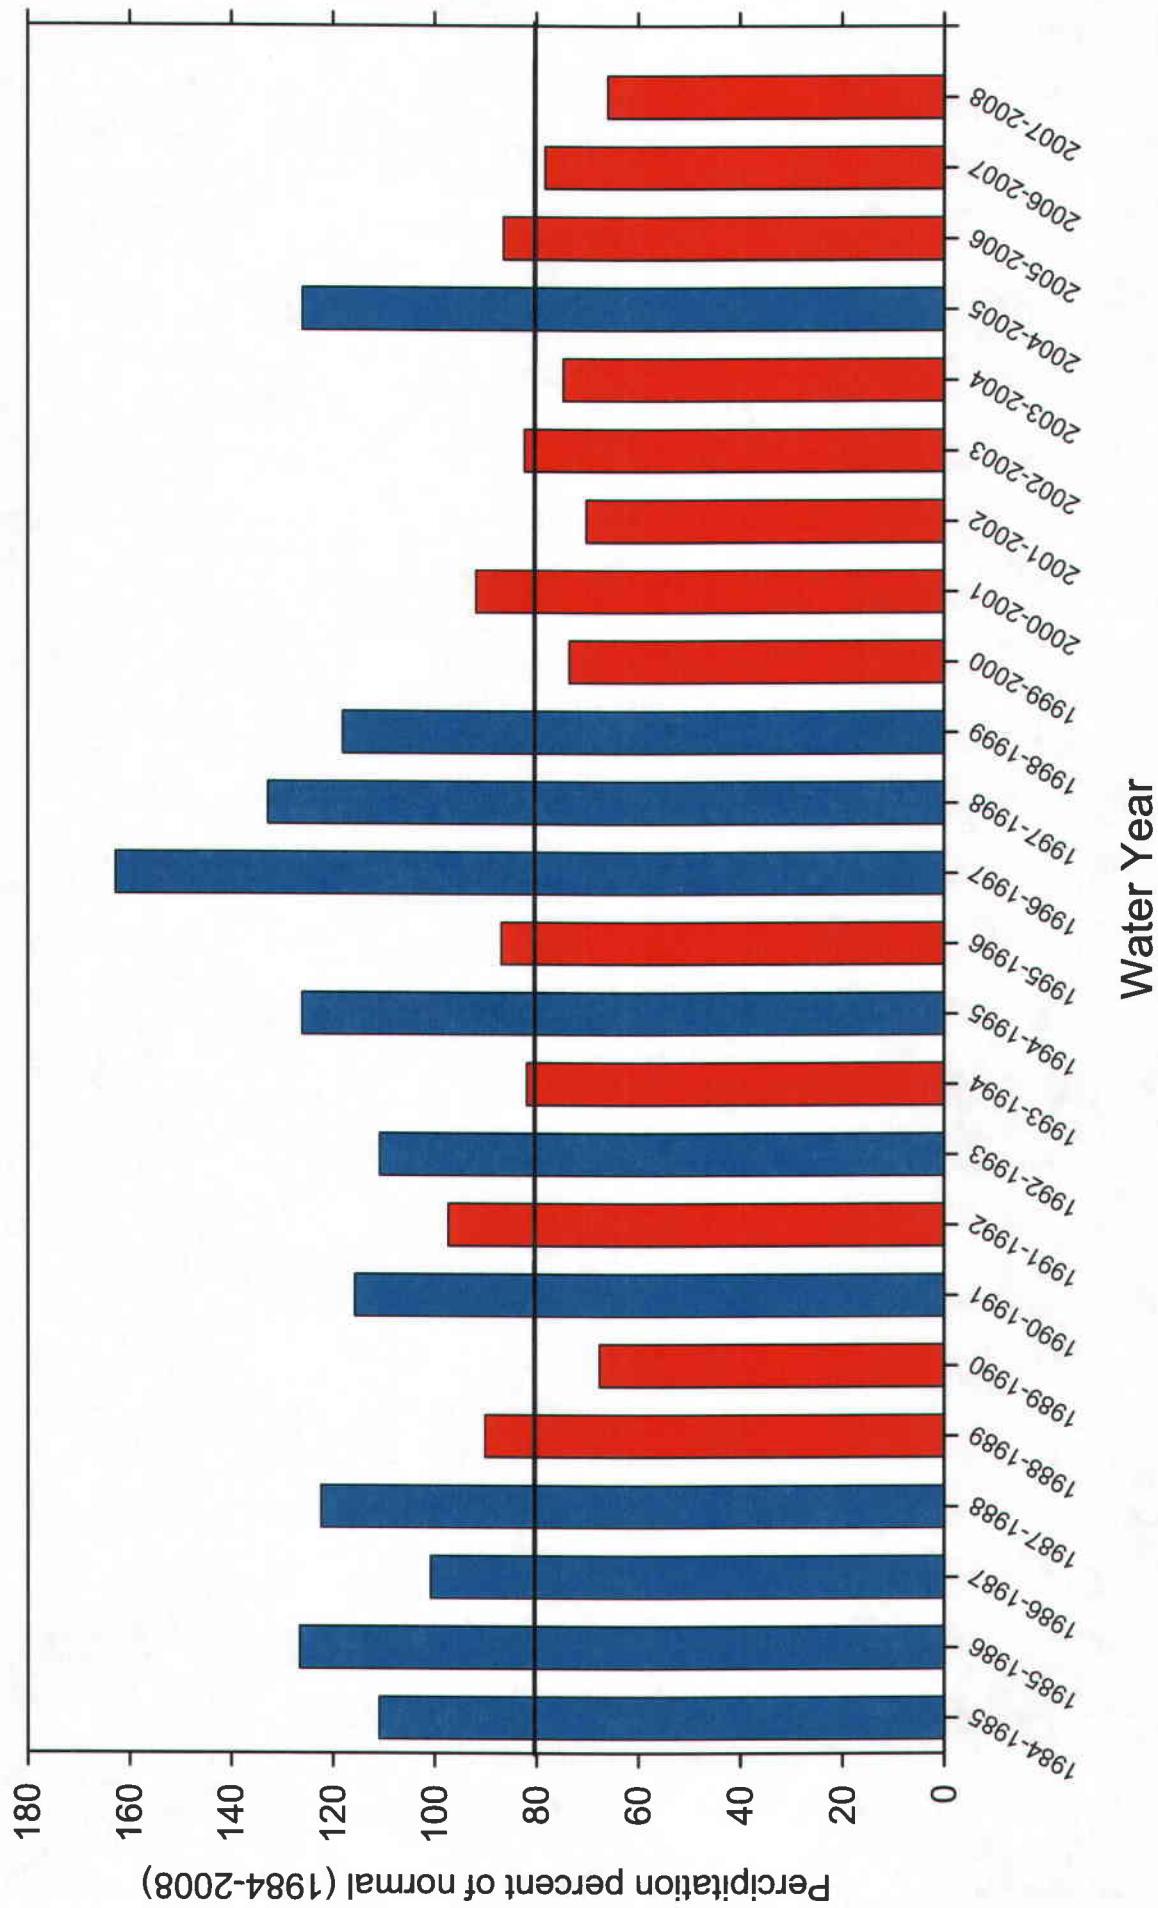
Figure 1 Sufco Mine Weather Station Precipitation

consequently does not contribute to groundwater recharge and surface-water flows in the Pines plateau area. Although regional climatic data are typically reflective of overall hydrologic conditions in the Pines area, measurements of precipitation falling in the local area is probably most useful in evaluating surface-water quantity and groundwater recharge rates. Locally, climatic data collected from the Salina 24E station during 2008 (Figure 1) indicates somewhat dryer conditions for the Sufco Mine area than that suggested by the regional climatic data. Precipitation measured at the Salina 24E station during 2008 was the lowest ever measured at the station (with 24 years of record). The annual precipitation measured at the station during eight of the last nine years has been below the station average, and each of the past three years has been dryer than the year preceding it, clearly indicating drought conditions in the area (Figure 1).

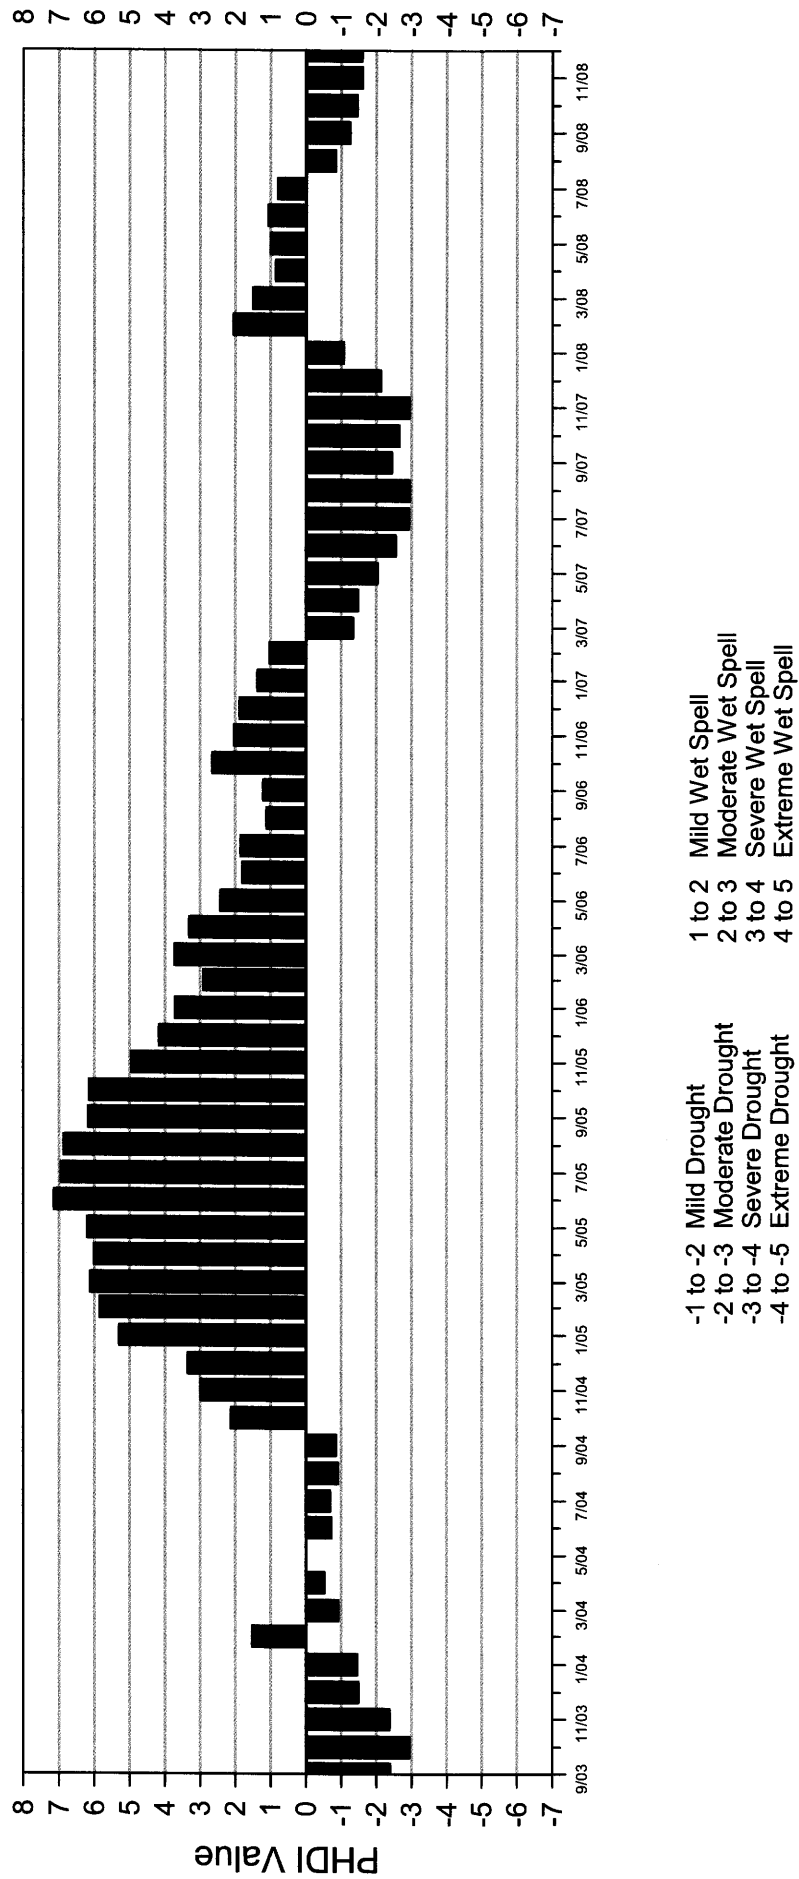
Figure 2 Plot of Palmer Hydrologic Drought Index for Utah Region 4.

The Palmer Hydrologic Drought Index (PHDI) has also been used in the flow comparisons presented below. A plot of the PHDI for Utah Region 4 is included in this analysis as Figure 2. The PHDI is a monthly numerical value generated by the National Climatic Data Center that indicates the severity of wet and dry spells. The PHDI is calculated from various hydrologic parameters including precipitation, temperature, evapotranspiration, soil water recharge, soil water loss, and runoff. Consequently, it is useful for evaluating the relationship between climatic conditions and groundwater and surface water discharge.

It is apparent in the plot of the PHDI that during the first half of 2008 the region (Utah Region 4) experienced a period of mostly near-normal to mildly wet conditions. During the second half of 2008, the region transitioned to a period of mild drought. It should be noted that the climatic conditions indicated in the PHDI for Utah Region 4 are calculated for a large region that includes most of central and south-central Utah. Additionally, because of the topographic setting and geologic conditions in the area, precipitation falling in the surrounding high-elevation mountainous areas is isolated from the Pines plateau area and

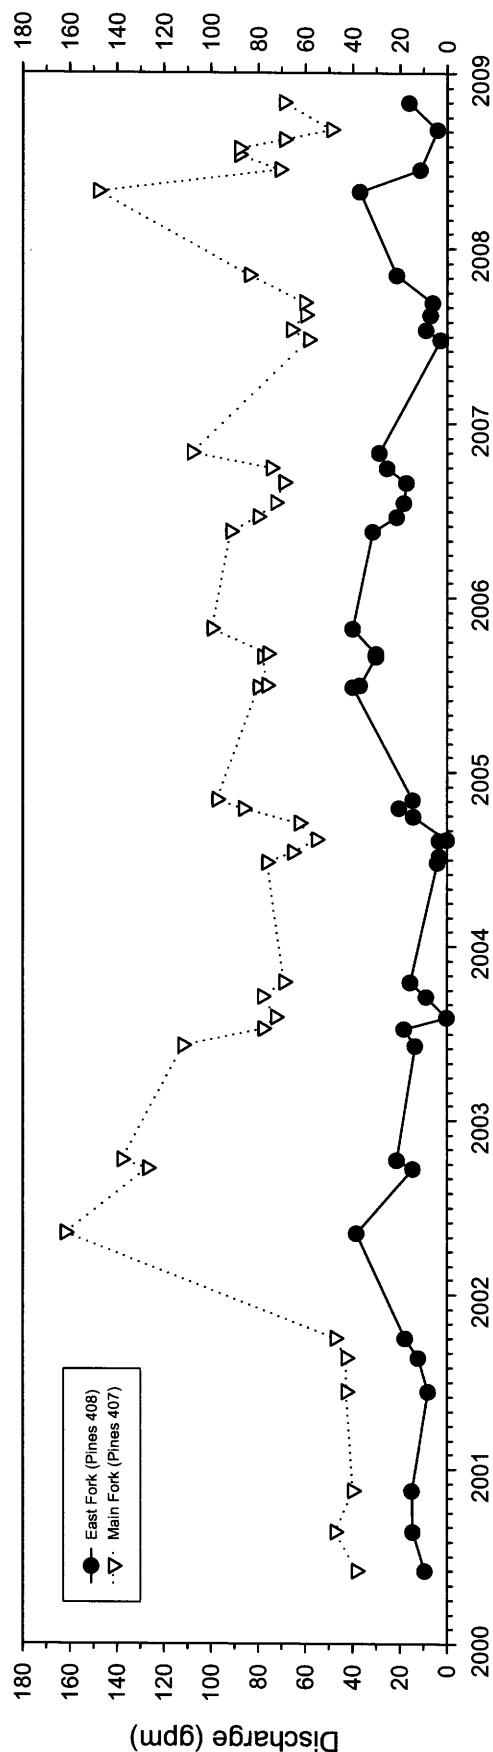
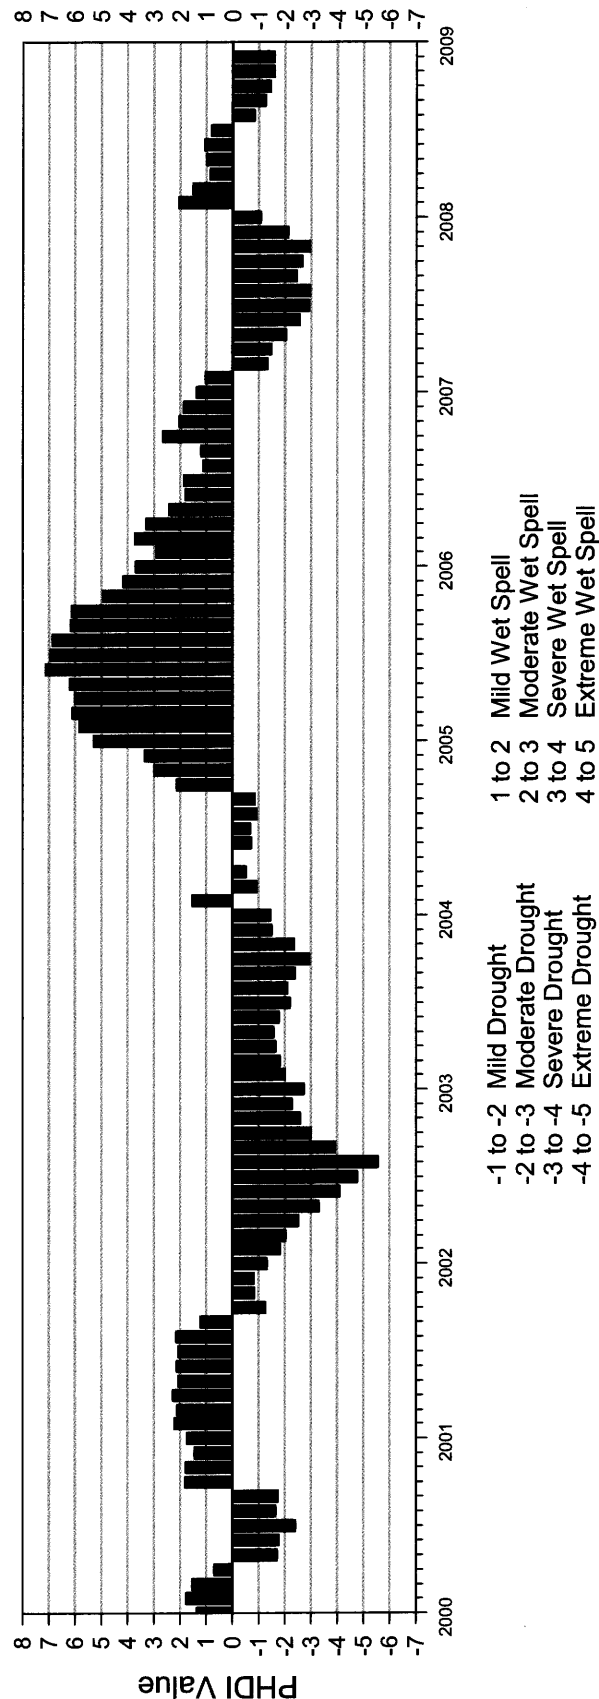
Figure 5 Discharge hydrographs for Pines 407 and Pines 408 and PHDI for Utah Region 4.

Comparison of discharge rates and climatic conditions in Box Canyon 2000-2008
for Pines 407 (main fork) and Pines 408 (East Fork)

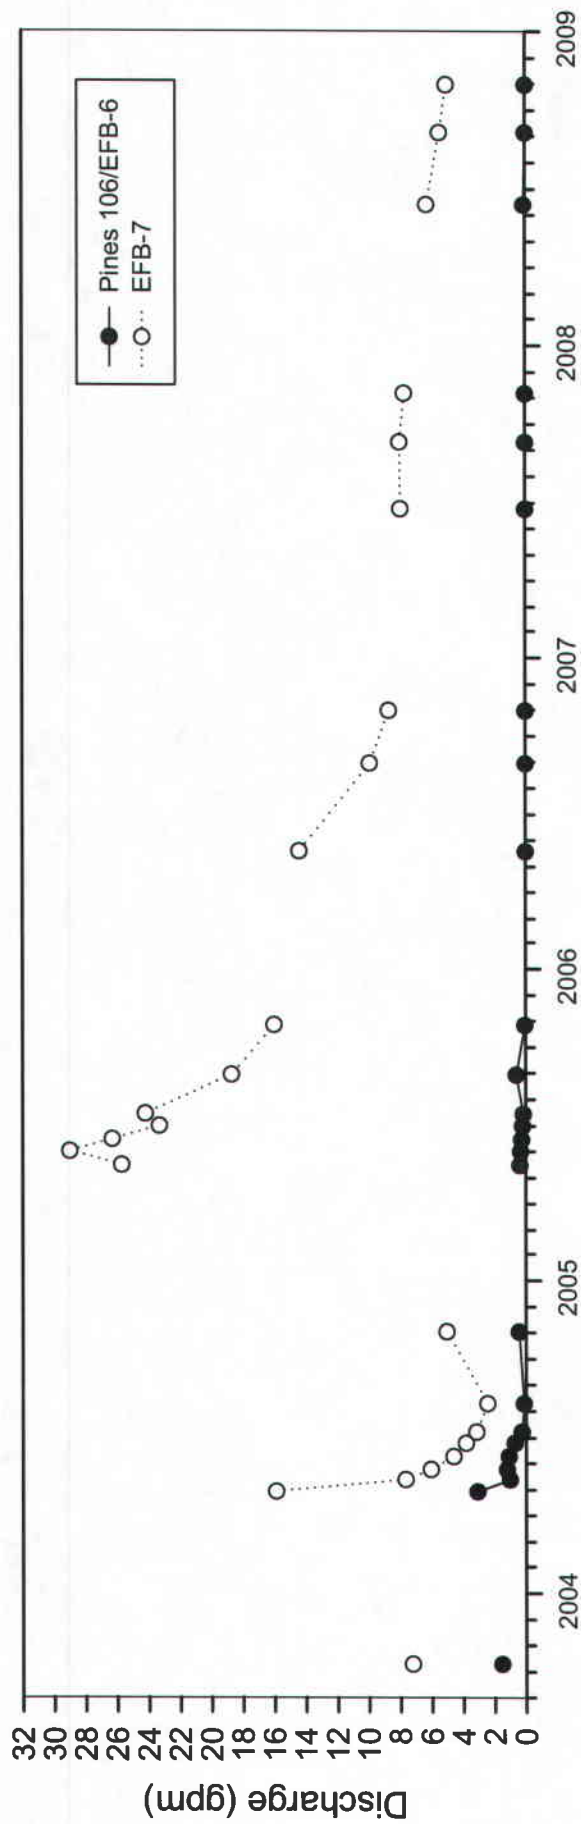
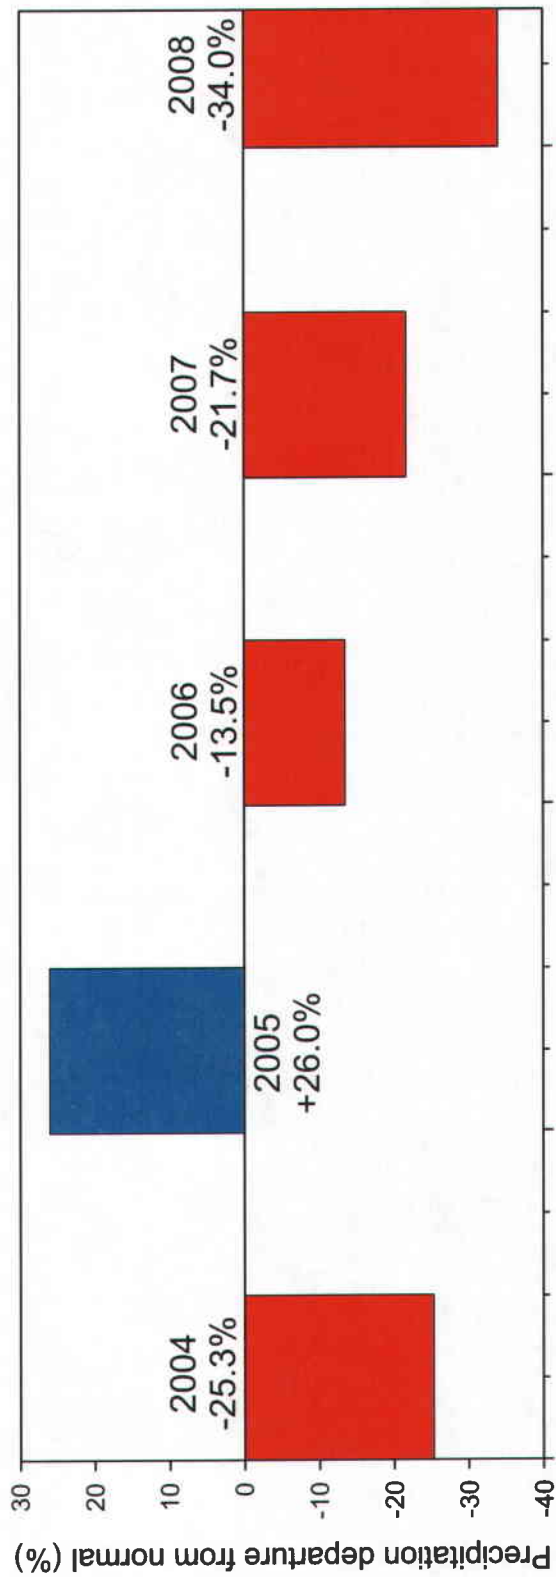
Figure 7 Pines 106/EFB-6 and EFB-7 discharge and Sufo Mine weather station data 2004-2008.

It is apparent in the plot of discharge from EFB-7 and Pines 106/EFB-6 (Figure 7) that discharge in the drainage at EFB-7 continued during 2008 at levels not inconsistent with those anticipated for the prevailing climatic (drought) conditions in the area during 2008 (as evidenced by the plots of yearly precipitation at the Salina 24E station in the Sufco permit area as shown in Figures 1 and 7).

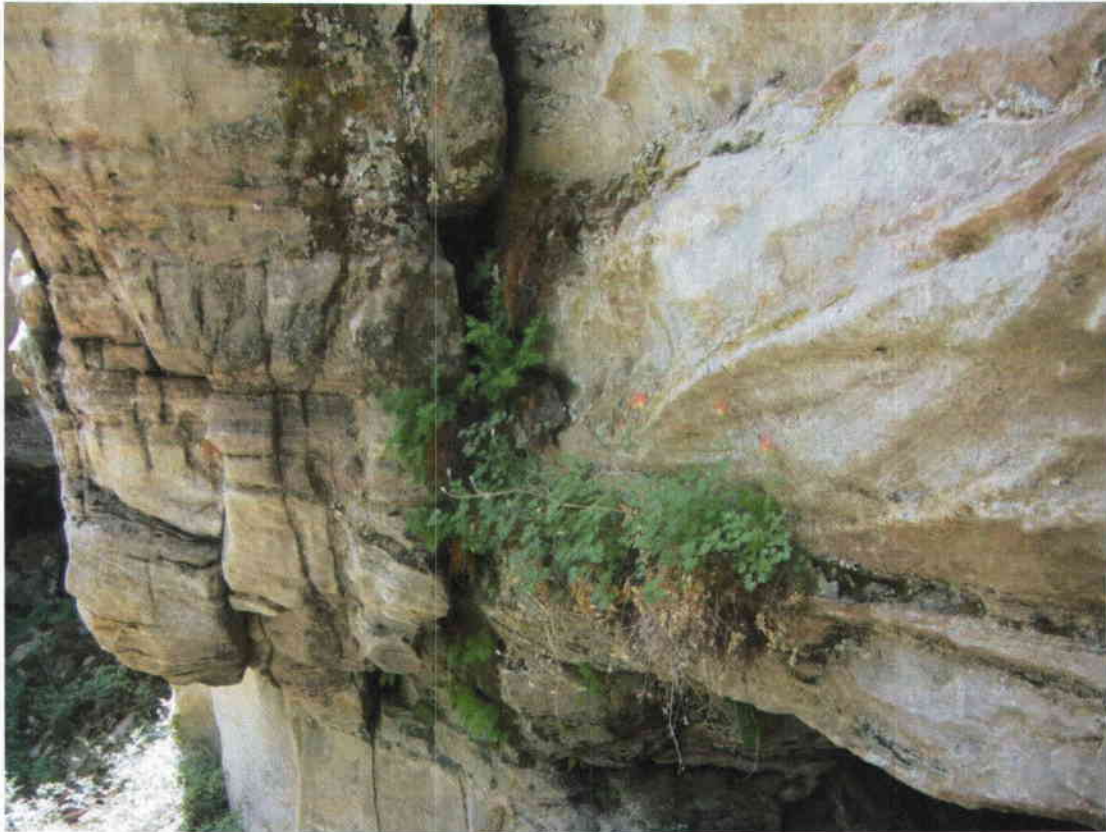
Photo Point 1a

At photo point 1a there is still one plant growing. It has a few inflorescences, which are 10-12 inches in length. There are about the same number of inflorescences as last year and the vigor is fair.

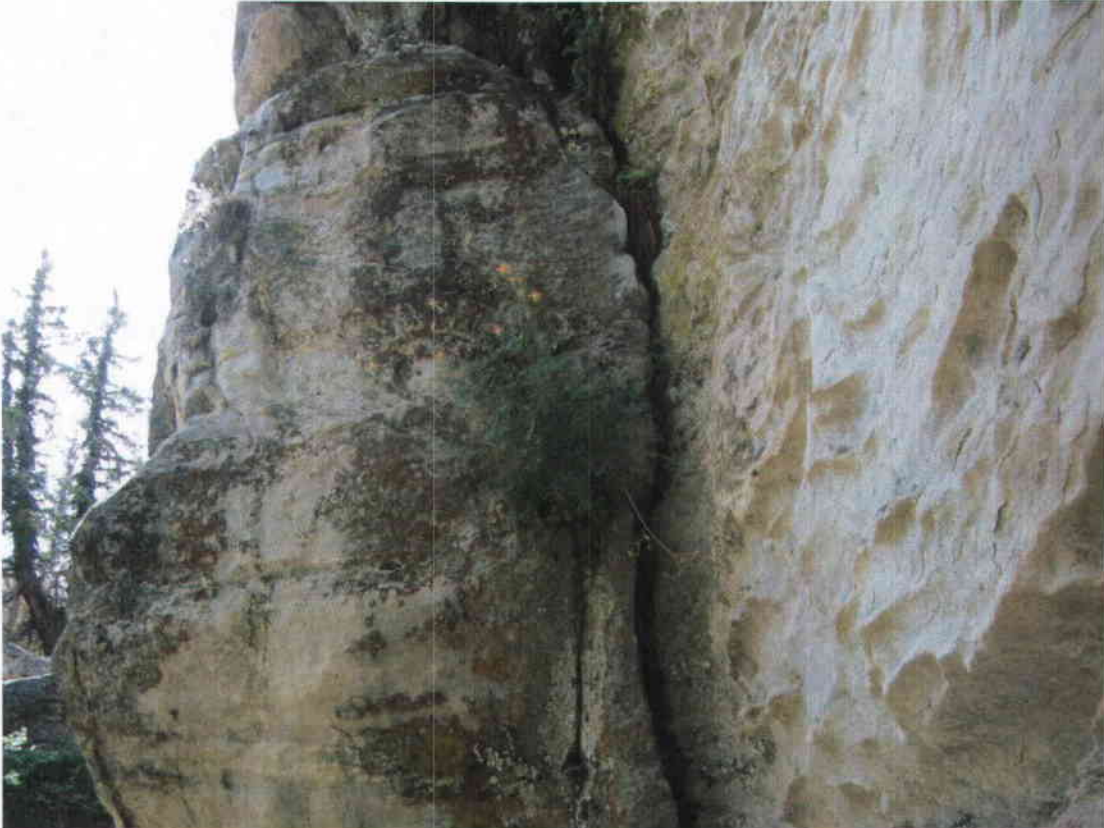
Photo Point 1b

At photo point 1b there are two columbine plants. One plant is in poor condition and appears to be dying while the other plant is healthy and has good vigor. Only the healthy plant has any inflorescence, which is 18-20 inches in length. Exact measurements cannot be made due to the location of the plants. These plants appear to be getting some moisture from the rock fractures that they are growing in.

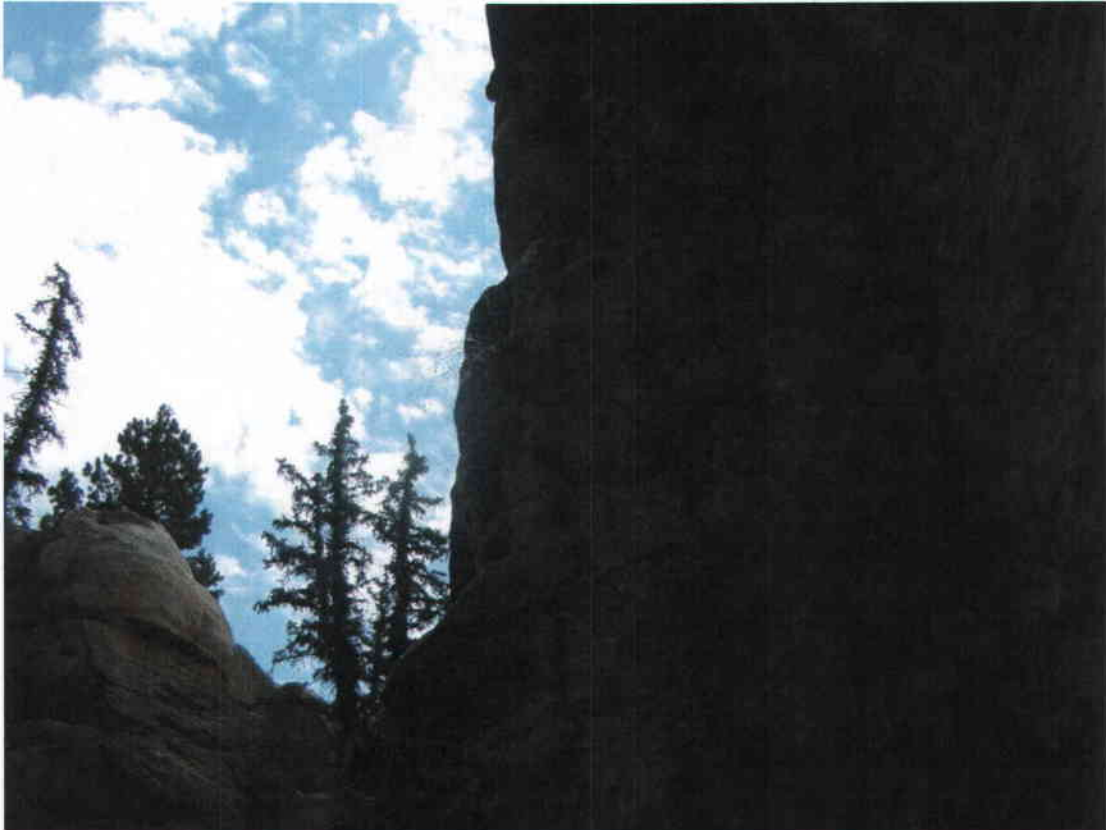
Photo Point 1c

At photo point 1c there is only one columbine plant and it is located approximately 20-25 feet up on the cliff face, so exact measurements cannot be made. There has been one plant at this photographic point in the past. It now appears that the plant has died.

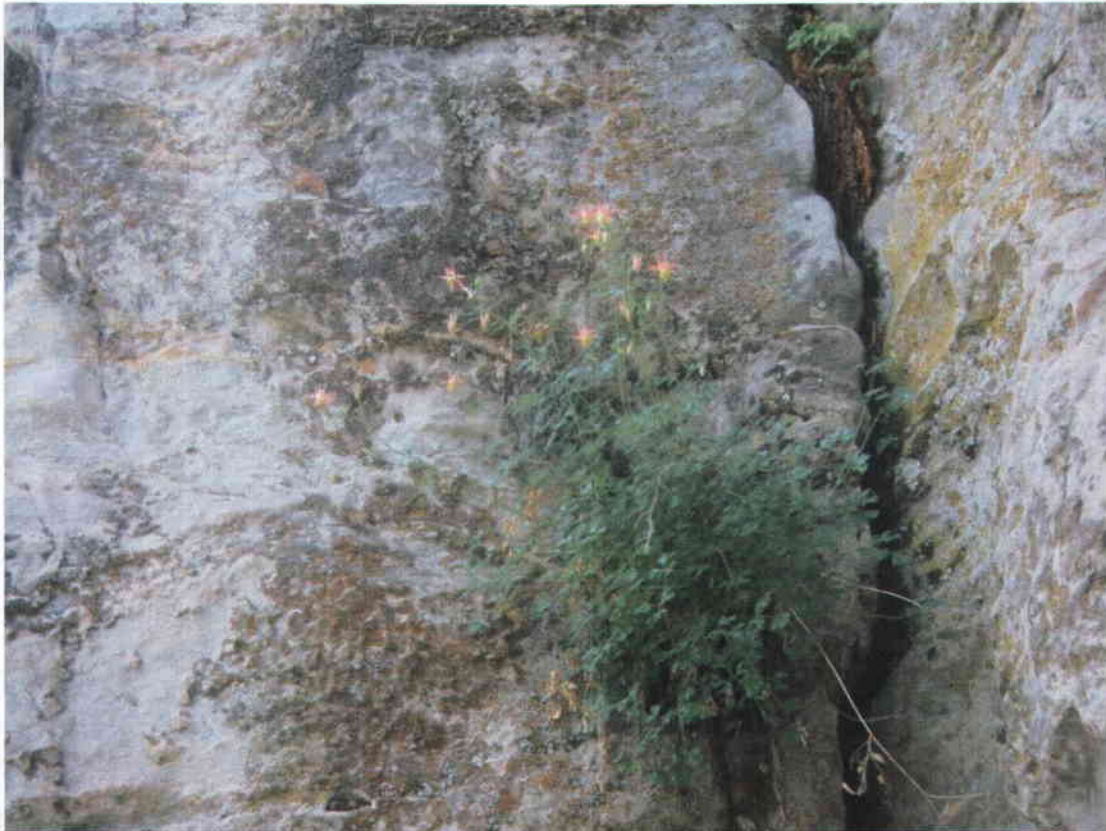
Photo Point 2

Last year there were three plants at this site, one dead, one dying and one in fair vigor. This year it appears that there are only two plants at this site, one dead and one that appears to be dying. The plants are located 20-25 feet up on the cliff face so exact measurements cannot be made. The inflorescence on the living plant appears to be 10-12 inches long and in fair condition.

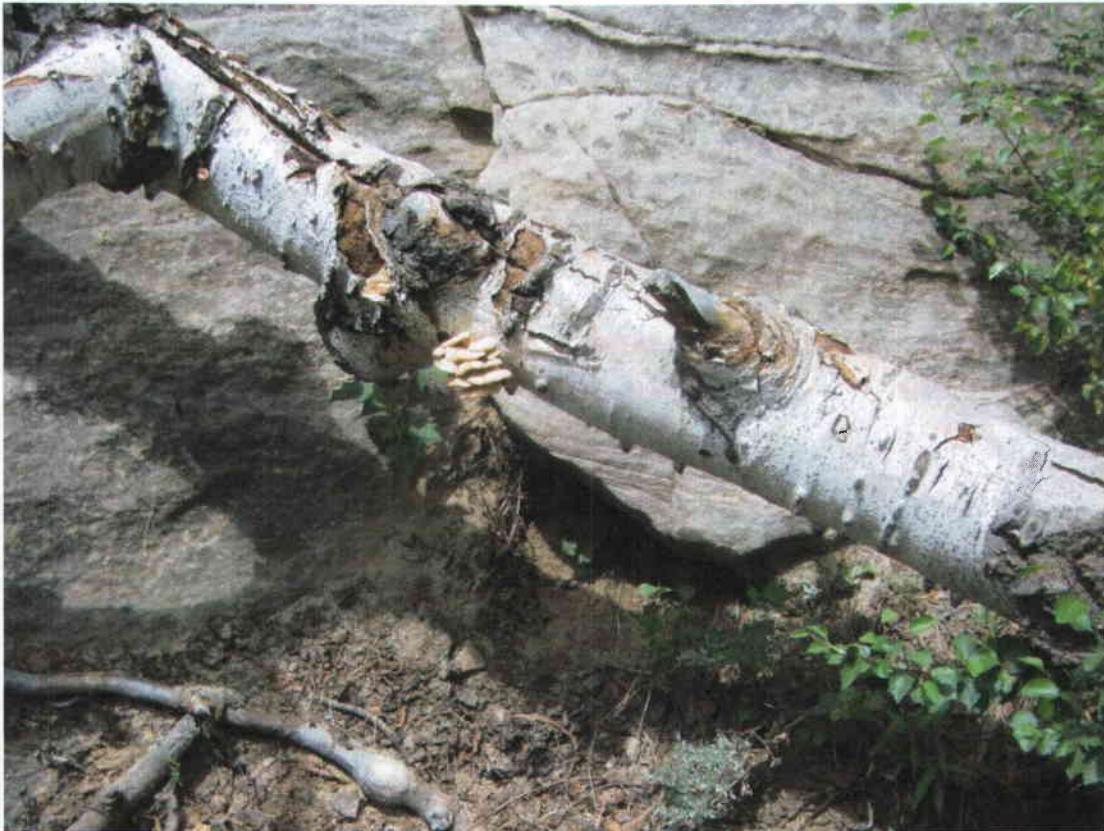
Photo Point 3

At this photographic point there has been two plants in the past, however, this year (2008) both of the previously existing plants are gone. No reminiscent of either plant could be found. The area has been heavily grazed but it could not be determined if grazing caused the plants to disappear. There is one new columbine seedling growing underneath the edge of the rock.

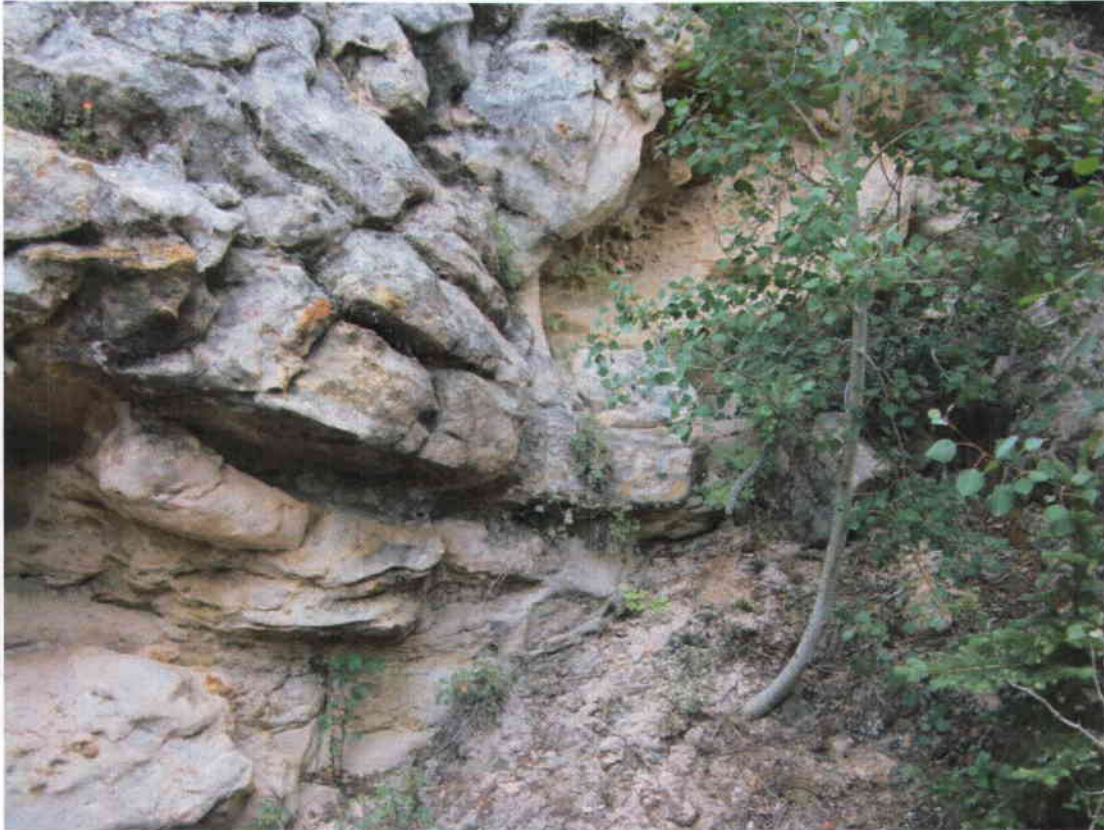
Photo Point 4

At this photographic point there are several columbine plants. Only two of the plants have inflorescence. One plant has an inflorescence of 9 inches while the other has an inflorescence of 12 inches. Both plants have fair vigor. The *Carex* plants are sparse and have a basal growth of 2-3 inches. Woods Rose has a new twig growth of 1-2 inches with no flowers or seed heads. The *Potentilla* plant has a new twig growth of 1 inch. This is a very dry site and the overall site is of low vigor, which is probably due to lack of moisture. The site has not been grazed.

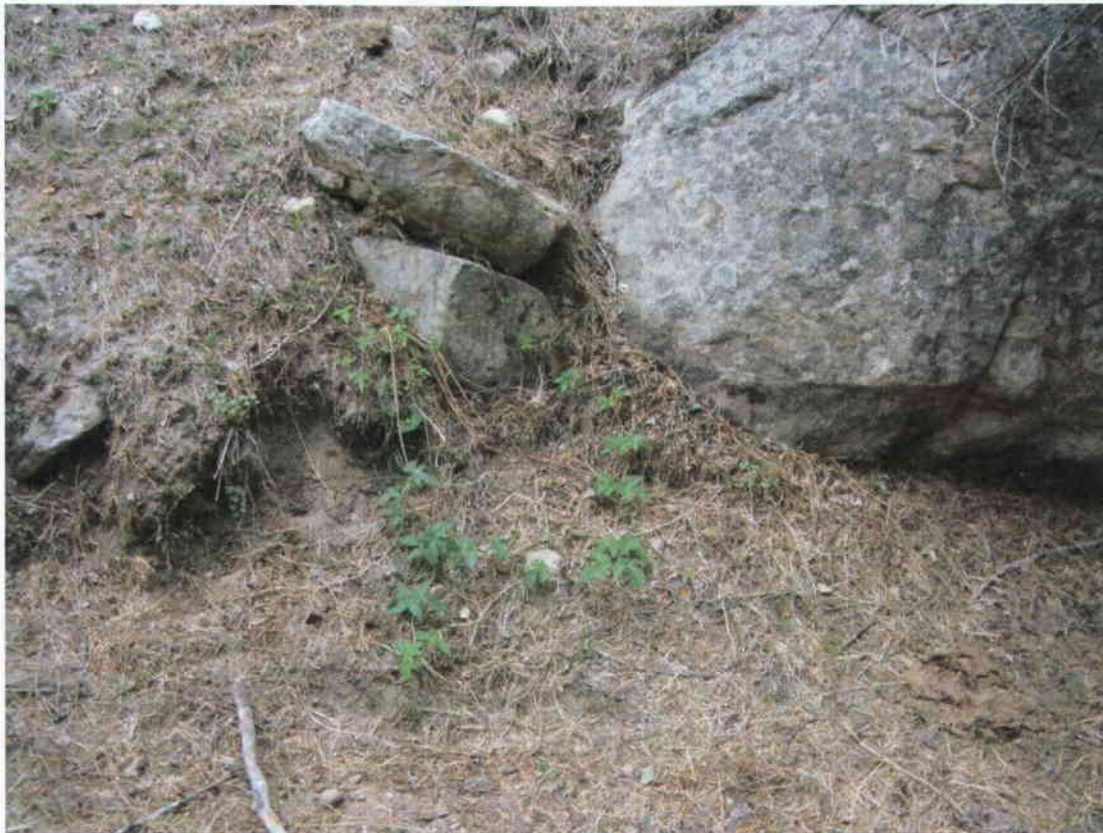
Photo Point 5

At this photographic point there are still three columbine plants. All three of the plants have been grazed. They have a basal growth of 3-4 inches and are in low vigor. The bluegrass has a sparse density and has been grazed down to the ground level and has no new re-growth. The *Carex* plants have been grazed and have a re-growth of 2-3 inches. The yarrow has no inflorescence and a basal growth of 2-3 inches. The Hairgrass has been grazed down to the ground level and is not visible. The site has approximately 30 percent bare ground with the remainder of the area having good ground litter. The overall vigor of the site is poor. There is no water in the creek at this site.

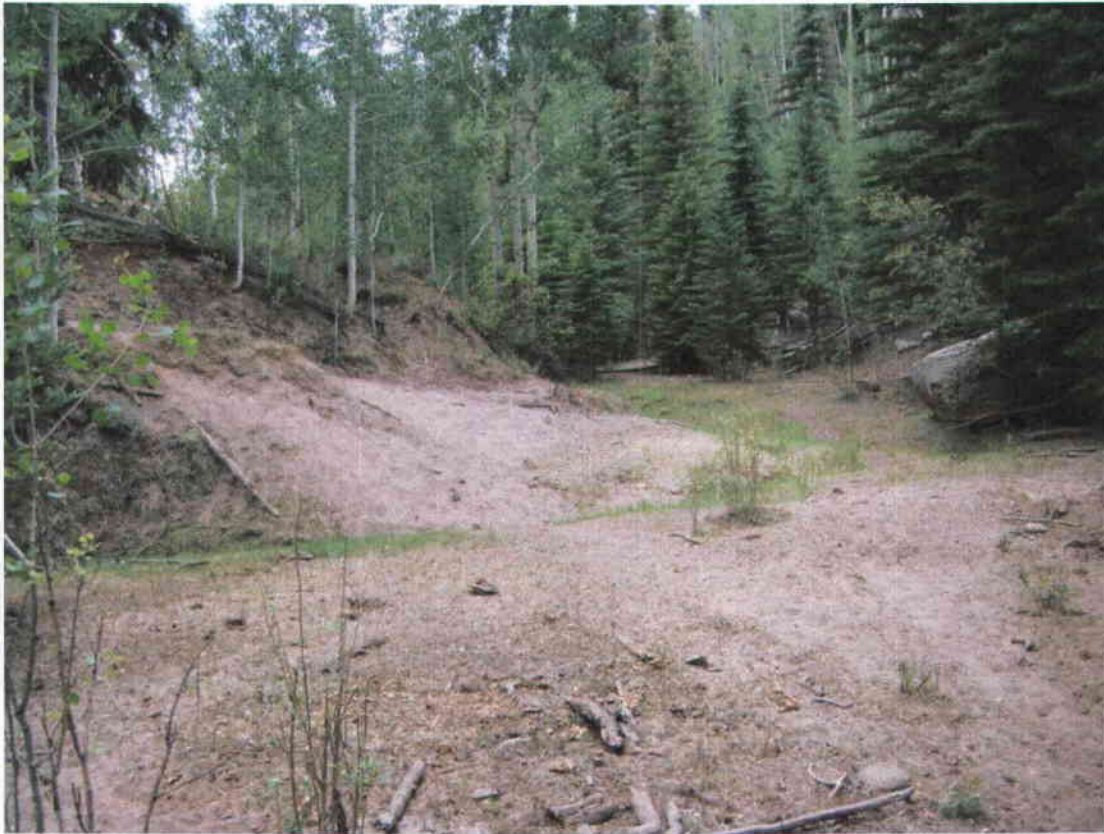
Photo Point 6

At this photographic point the site is dry and has been heavily grazed by livestock. Ocular estimate show that the site to have approximately 50% bare ground with only fair ground litter. Aspen has a new twig growth of 8-12 inches with the majority of the twigs having been grazed off. Woods Rose has a new twig growth of 4-8 inches with no flowers or seed heads. Yarrow has been heavily grazed with no inflorescence with a basal growth of 2-3 inches. Bluegrass has been grazed down to ground level. Herbaceous sage has been heavily grazed and a basal growth of 4-6 inches. *Carex* has been heavily grazed and has new re-growth of 2-3 inches. Wiregrass has been grazed down to 4-6 inch height and has a very low density. Overall the vigor at this site is poor. There is no water in the Creek.

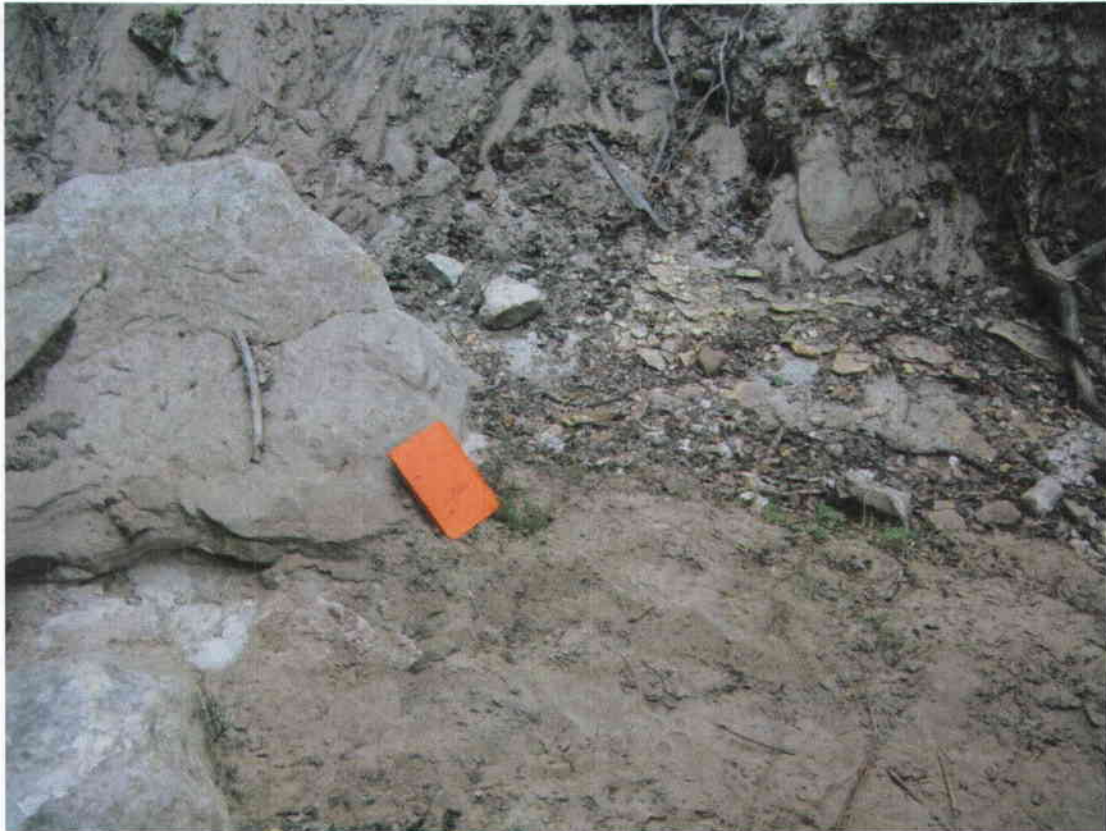
Photo Point 7

At this photographic point there are still no columbine plants. The site has been heavily grazed by livestock, with none of the existing plants having any inflorescence. Geranium has a basal growth of 2-3 inches. Yarrow has a basal growth of 2 inches. *Carex* has a basal growth of 1 inch. Horsetail has a basal growth of 2 inches. No bluegrass plants could be found. The site is 90-95 % bare ground. Vigor is poor. There is no water in the Creek.

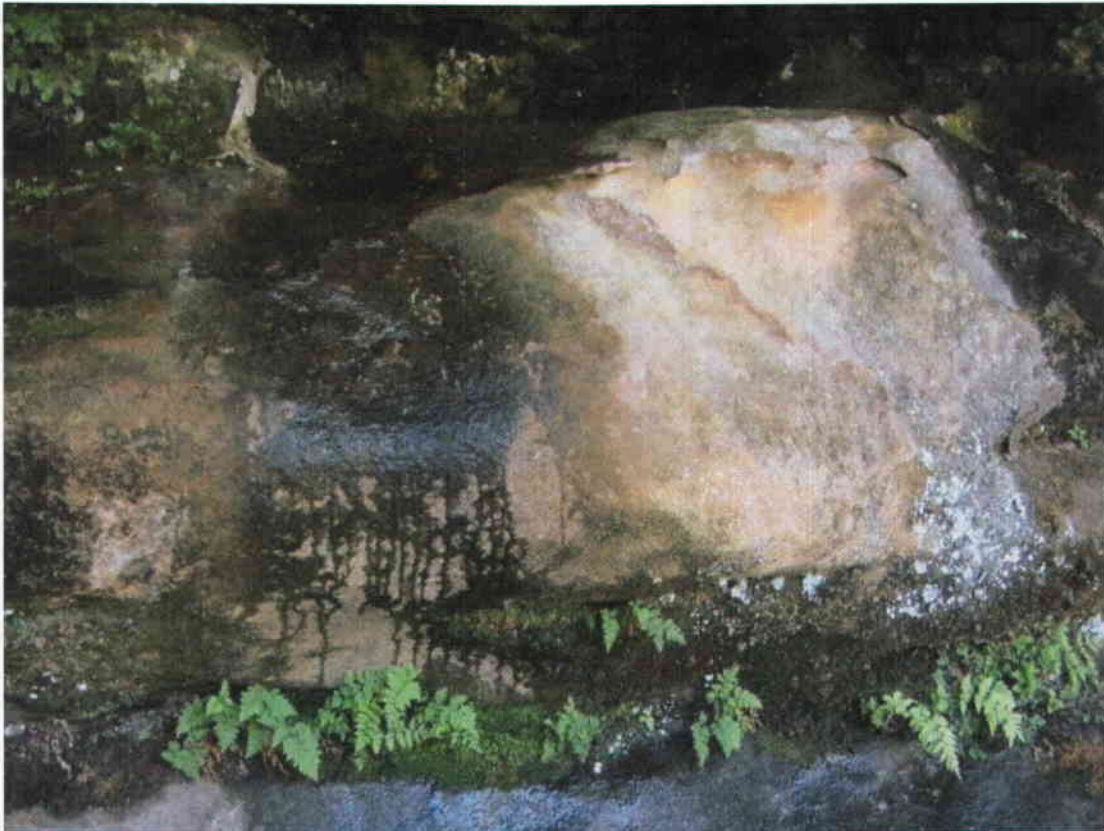
Photo Point 8

This photographic point is a hanging fern area located in the "Grotto" area. The ferns and the lichens receive moisture that is coming from the fractures in the cliff face. The fern density appears to be slightly more than last year with the ferns having a current growth of 4-6 inches. There also appears to be more lichens this year than last year. There is more moisture seeping from the fractures than last year. The seepage is too small of flow to be measured.

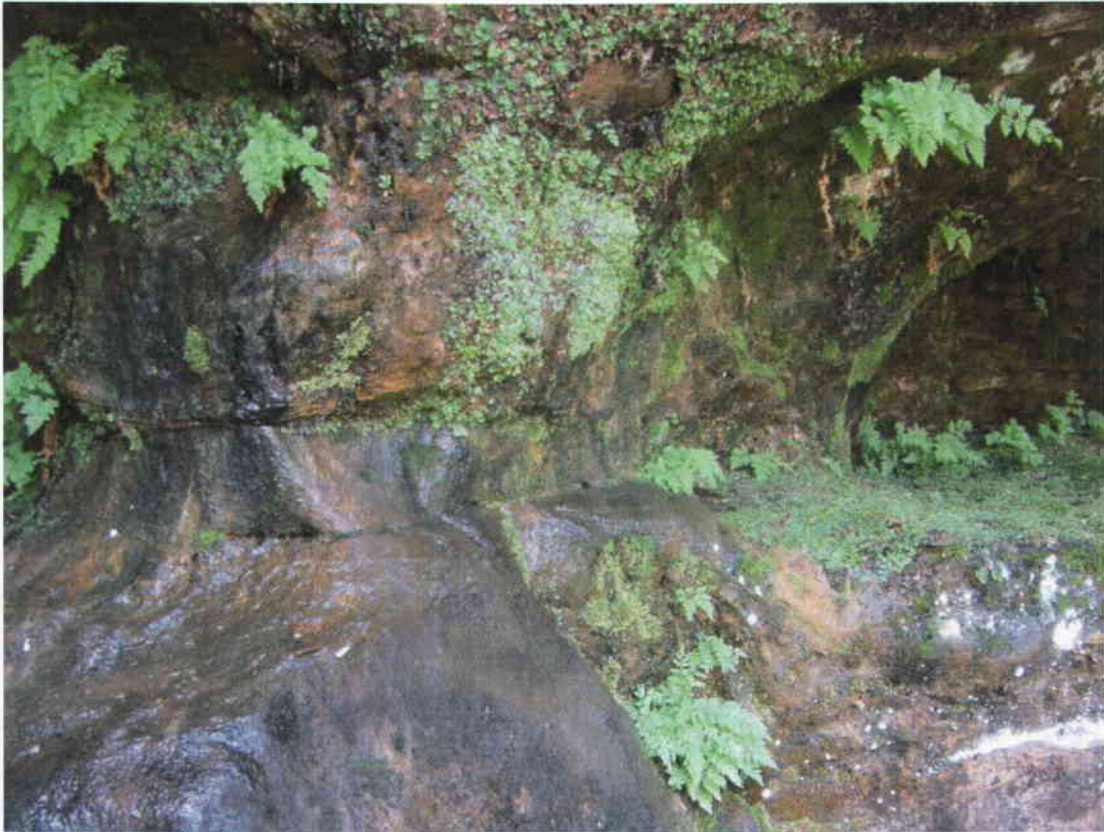
Photo Point 9a

At this photographic point there is moisture coming from the fractures in the cliff face and is located in the "Grotto" area. . The moisture appears to be more than last year. The moisture flow cannot be measured. The ledge is covered with a good growth of lichens. The ferns have a current growth of 5-7 inches.

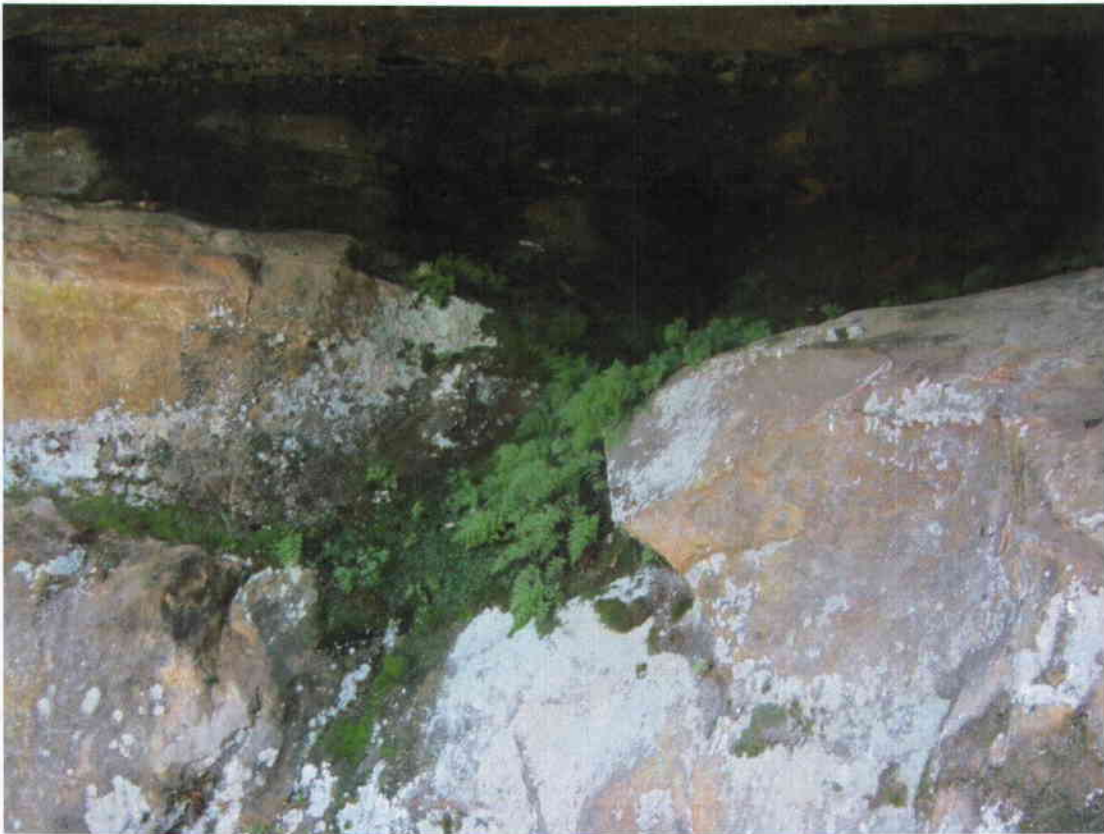
Photo Point 9b

At this photo point there is moisture coming from the fractures in the cliff face and is located in the "Grotto" area. Some small pools of water have been formed from the dripping water. The lichen growth and density appears to have increased since last year. This increase in lichen growth appears to be at the expense of fern density, which is less than that of last year. The current growth of the ferns is 6-8 inches.

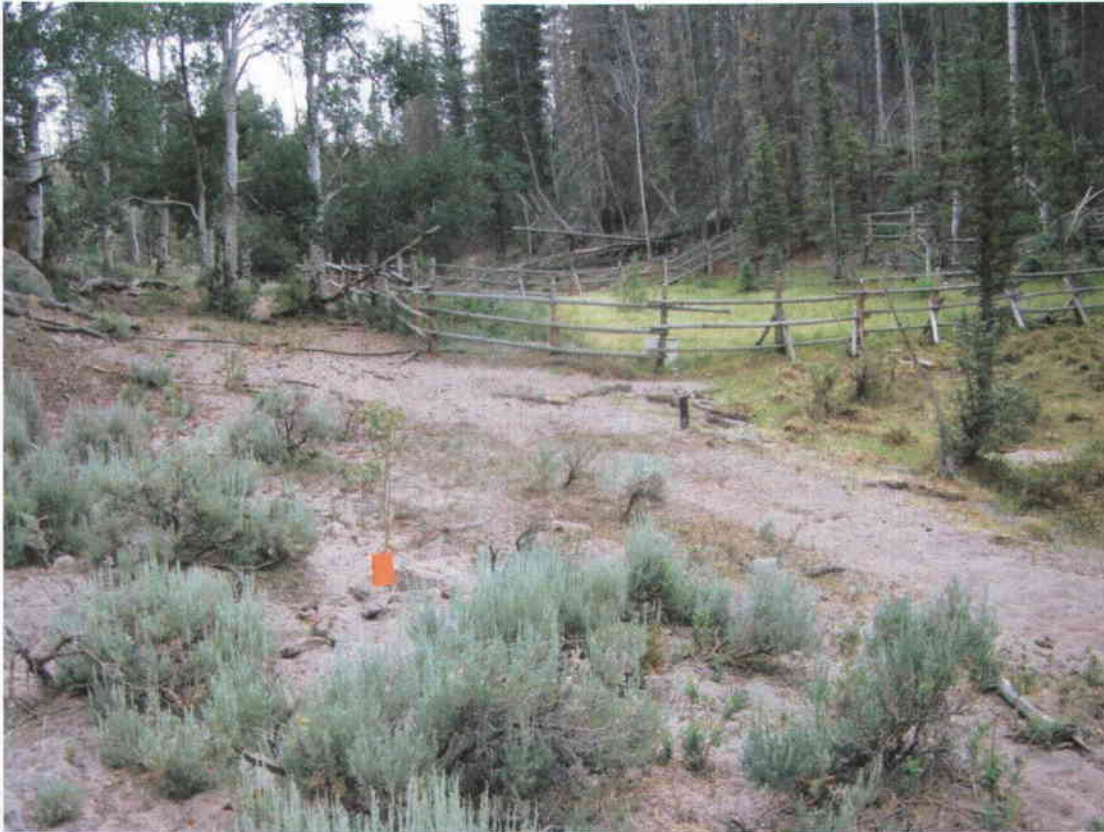
Photo Point 10

This photographic point was originally a dry meadow site but is fast becoming a dry sagebrush/grassland site. The site has been heavily grazed by domestic livestock, this year. All of the species on the site except sagebrush have been heavily grazed. The Aspen have some re-growth of 3-5 inches. The sagebrush has a current years growth of 4-6 inches. There were a few current years growth of woods rose found which had a current twig growth of 3 inches. The sparse density of wiregrass had been heavily grazed with a stubble height of 4 inches still remaining. All of the grass species have been grazed down to ground level. The overall condition and vigor of this site is very poor. Ocular estimate show the site to have 70% bare ground.

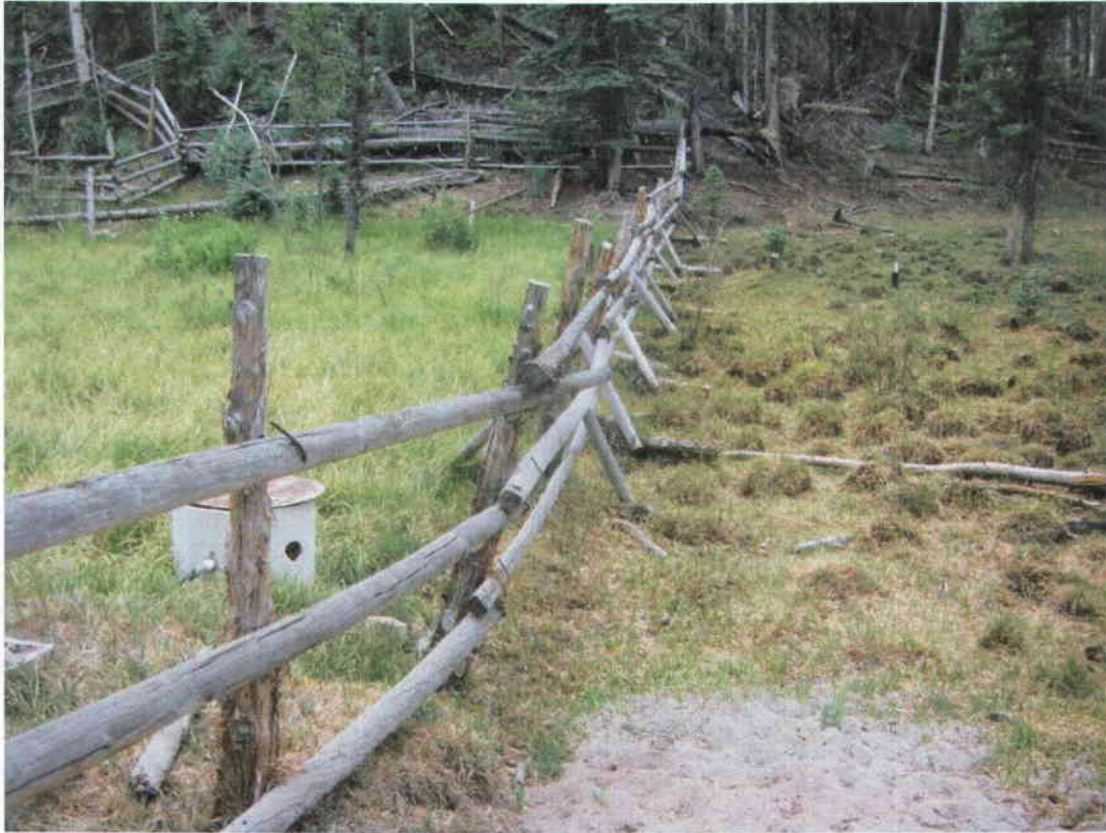
Riparian Area adjacent to Photo Point 10

This photograph shows a contrast between the grazed area and the fenced enclosure, which is adjacent to photographic point 10. Although spring "Pines 105" is not flowing the riparian area is still remaining green and showing good vigor in the protected area.
